**Flood Control Project Maintenance
Levee Inspections**

Fall 2011 Levee Maintenance Deficiency Summary Report

Sacramento River Basin

Sutter Maintenance Yard Maintenance Area 0005

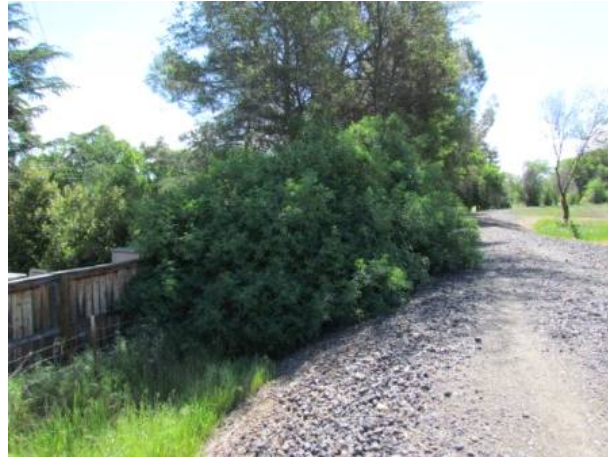
Levee Mile Report Line	1
Start Levee Mile	0.58
End Levee Mile	0.58
Location	Land Side
Category	Earthen Levee
Item	Vegetation

LMR No.	Levee Mile		Category	Item	Location *	Rating **	Action/Comment	GPS Latitude/Longitude		Issue No.
	Start	End						Start	End	
1	0.58	0.58	Earthen Levee	Vegetation	LS	M	Elderberries are blocking visibility and flood fight capability.	39.690745 ° -121.777342 °	39.690745 ° -121.777342 °	903 Y
2	1.68	1.68	Earthen Levee	Encroachments	LS	M	Debris	39.675528 ° -121.778642 °	39.675528 ° -121.778642 °	1 Y
3	2.13	2.13	Earthen Levee	Repair Gates	CR	M		39.670112 ° -121.782012 °	39.670112 ° -121.782012 °	10
4	2.86	2.86	Earthen Levee	Encroachments	LS	M	Prunings	39.660124 ° -121.785136 °	39.660124 ° -121.785136 °	2 Y
5	3.12	3.12	Earthen Levee	Encroachments	LS	M	Prunings	39.656779 ° -121.787127 °	39.656779 ° -121.787127 °	3
6	3.27	3.27	Earthen Levee	Encroachments	LS	M	Prunings	39.654847 ° -121.787893 °	39.654847 ° -121.787893 °	4 Y
7	9.66	10.48	Earthen Levee	Encroachments	WS	PO	Agricultural Ditch	39.574837 ° -121.807913 °	39.567892 ° -121.819283 °	5 Y

View of the large elderberries along the L/S toe.

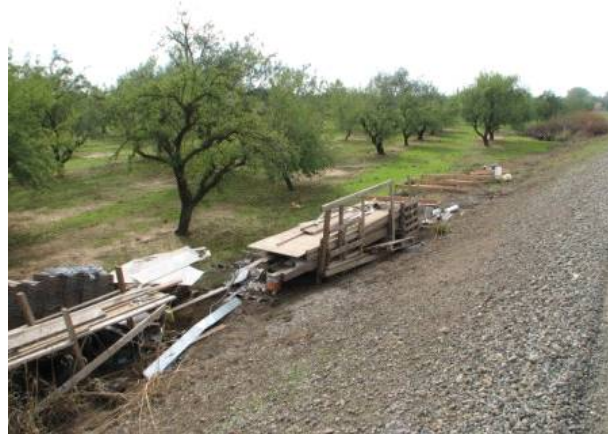
Levee Mile Report Line	2
Start Levee Mile	1.68
End Levee Mile	1.68
Location	Land Side
Category	Earthen Levee
Item	Encroachments

View of the removed garbage but construction supply on pallets.

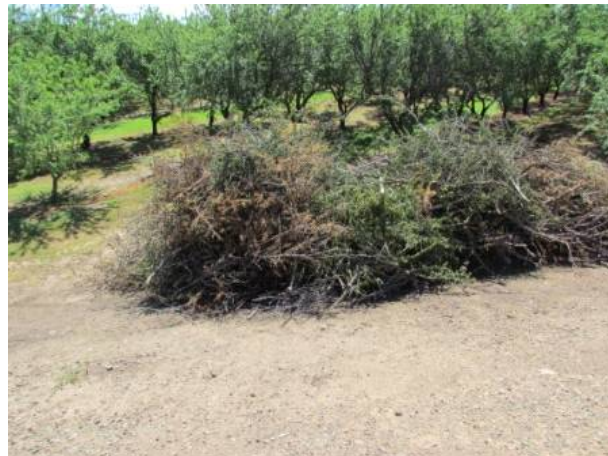
Levee Mile Report Line	4
Start Levee Mile	2.86
End Levee Mile	2.86
Location	Land Side
Category	Earthen Levee
Item	Encroachments

View of the large pruning along the L/S toe.

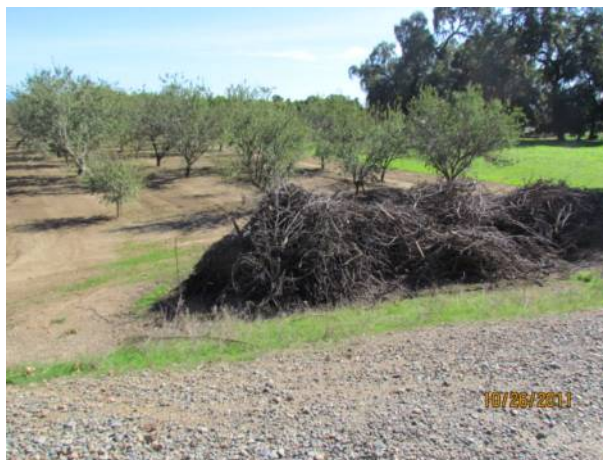
Levee Mile Report Line	6
Start Levee Mile	3.27
End Levee Mile	3.27
Location	Land Side
Category	Earthen Levee
Item	Encroachments

View of pruning along the L/S toe.

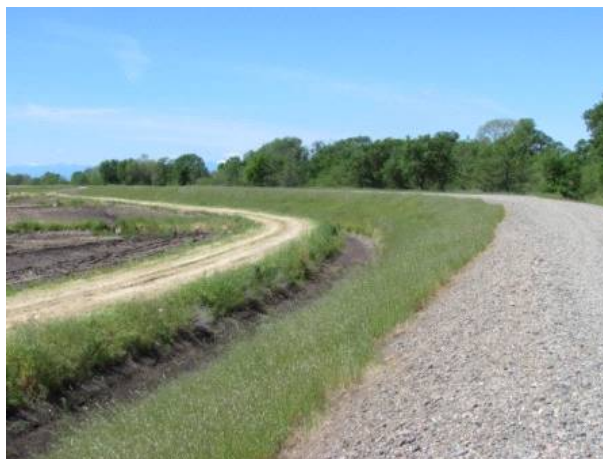
Levee Mile Report Line	7
Start Levee Mile	9.66
End Levee Mile	10.48
Location	Water Side
Category	Earthen Levee
Item	Encroachments

View of the AG ditch along the L/S toe.

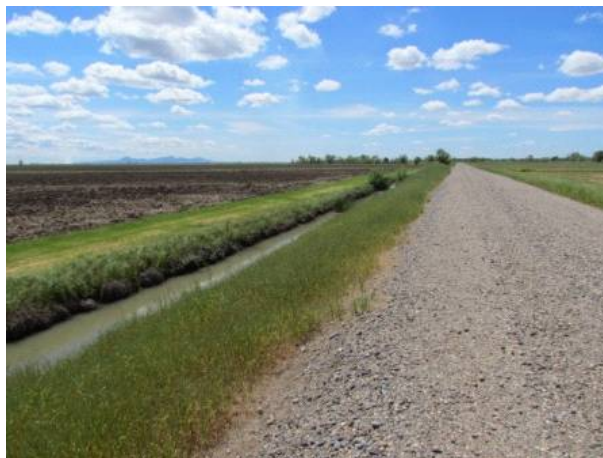
Levee Mile Report Line	8
Start Levee Mile	12.00
End Levee Mile	13.83
Location	Land Side
Category	Earthen Levee
Item	Encroachments

8	12.00	13.83	Earthen Levee	Encroachments	LS	PO	Agricultural Ditch	39.551235 ° -121.837697 °	39.531462 ° -121.856165 °	6 Y

View of the AG ditch along the L/S toe.

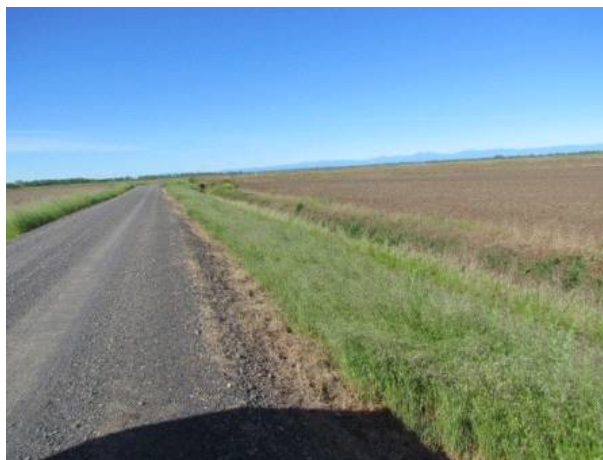
Levee Mile Report Line	1
Start Levee Mile	1.23
End Levee Mile	1.62
Location	Land Side
Category	Earthen Levee
Item	Encroachments

View of the AG ditch along the L/S toe.

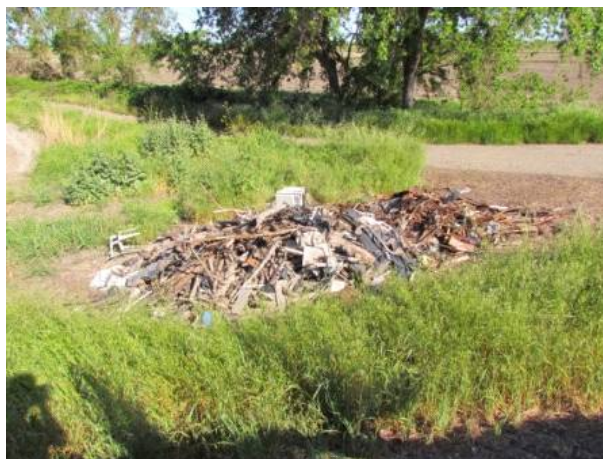
Levee Mile Report Line	2
Start Levee Mile	1.89
End Levee Mile	1.89
Location	Land Side
Category	Earthen Levee
Item	Encroachments

View of the garbage along the L/S toe.

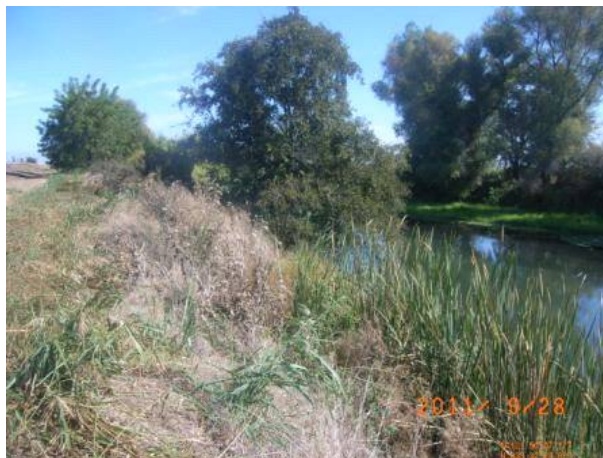
Levee Mile Report Line	3
Start Levee Mile	2.50
End Levee Mile	2.51
Location	Water Side
Category	Supplemental
Item	USACE Erosion Survey

USACE 2011 Photo #1

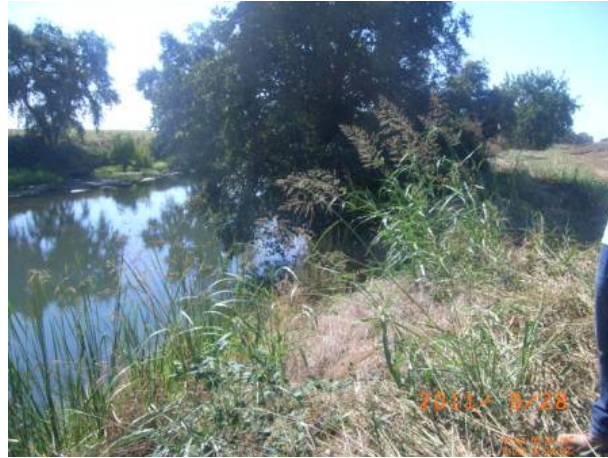
Levee Mile Report Line	3
Start Levee Mile	2.50
End Levee Mile	2.51
Location	Water Side
Category	Supplemental
Item	USACE Erosion Survey

USACE 2011 Photo #2

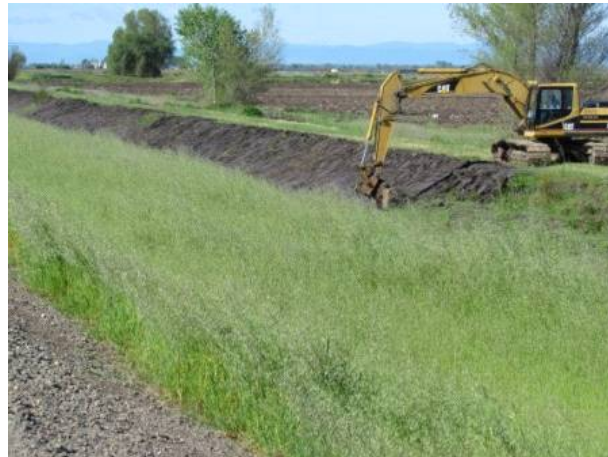
Levee Mile Report Line	4
Start Levee Mile	3.15
End Levee Mile	4.60
Location	Land Side
Category	Earthen Levee
Item	Encroachments

View of the AG ditch along the L/S toe.

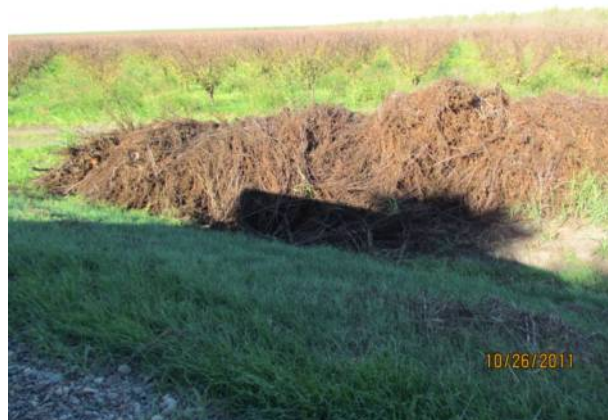
Levee Mile Report Line	5
Start Levee Mile	7.38
End Levee Mile	7.38
Location	Land Side
Category	Earthen Levee
Item	Encroachments

View of the pruning along the L/S toe.

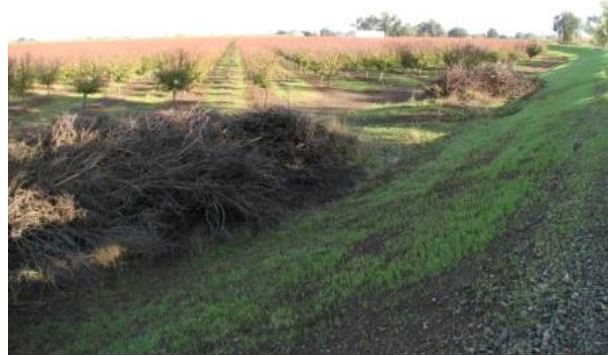
Levee Mile Report Line	6
Start Levee Mile	7.86
End Levee Mile	7.86
Location	Land Side
Category	Earthen Levee
Item	Encroachments

6	7.86	7.86	Earthen Levee	Encroachments	LS	M	Prunings	39.605265 ° -121.788388 °	39.605265 ° -121.788388 °	2 Y
7	10.54	10.54	Earthen Levee	Encroachments	LS	M	Prunings	39.639018 ° -121.781458 °	39.639018 ° -121.781458 °	3
8	10.61	10.61	Earthen Levee	Encroachments	LS	M	Buildings	39.639967 ° -121.782152 °	39.639967 ° -121.782152 °	14 Y
9	10.81	10.81	Earthen Levee	Slope Stability	LS	M	Repair the levee slope damaged by foot traffic and prevent access where possible.	39.642447 ° -121.784105 °	39.642447 ° -121.784105 °	16 Y
10	11.22	11.22	Earthen Levee	Vegetation	LS	M	Elderberries are blocking visibility and flood fight capability.	39.647400 ° -121.787825 °	39.647400 ° -121.787825 °	26
11	11.74	11.95	Earthen Levee	Encroachments	LS	PO	Agricultural Ditch	39.654268 ° -121.789525 °	39.657142 ° -121.788690 °	6 Y
12	13.23	13.23	Earthen Levee	Encroachments	LS	M	Equipment	39.673956 ° -121.781278 °	39.673956 ° -121.781278 °	5

View of the debris and garbage along the landside toe of the levee.

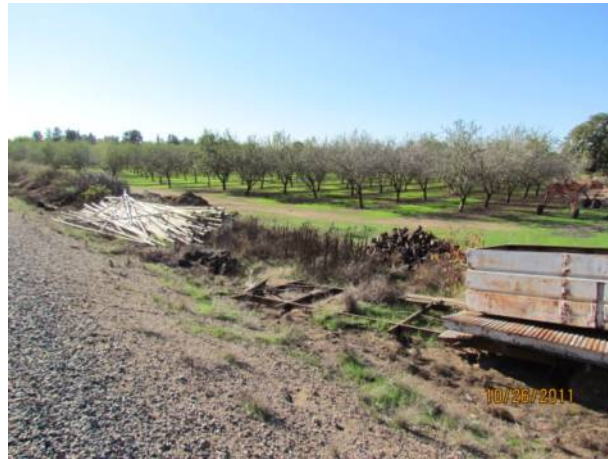
Levee Mile Report Line	8
Start Levee Mile	10.61
End Levee Mile	10.61
Location	Land Side
Category	Earthen Levee
Item	Encroachments

View of the equipment along the L/S toe.

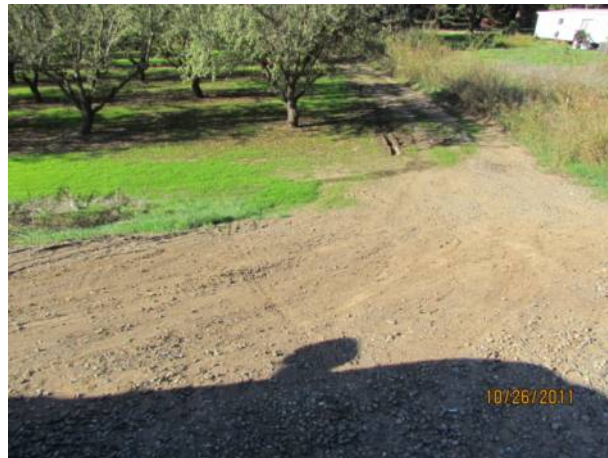
Levee Mile Report Line	9
Start Levee Mile	10.81
End Levee Mile	10.81
Location	Land Side
Category	Earthen Levee
Item	Slope Stability

View of the vehicle erosion along the L/S slope.

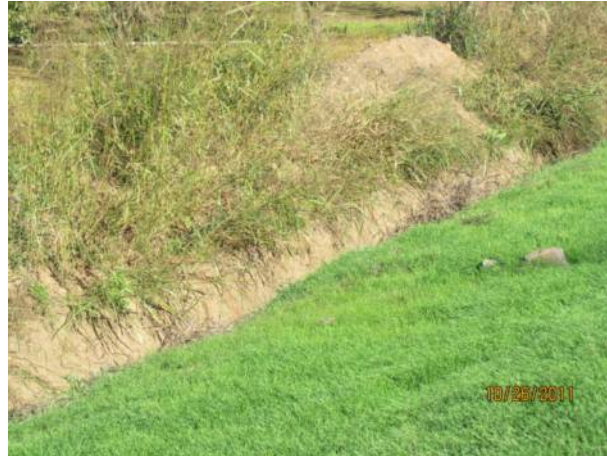
Levee Mile Report Line	11
Start Levee Mile	11.74
End Levee Mile	11.95
Location	Land Side
Category	Earthen Levee
Item	Encroachments

View of the ditch along the L/S toe.

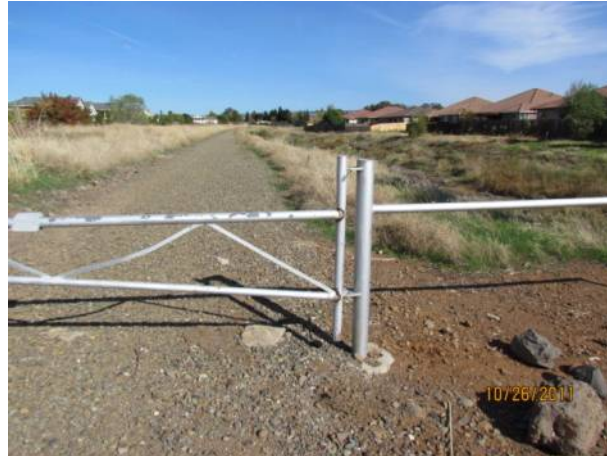
LMR No.	Levee Mile		Category	Item	Location *	Rating **	Action/Comment	GPS Latitude/Longitude		Issue No.
	Start	End						Start	End	Photo
1	0.70	0.70	Earthen Levee	Repair Gates	CR	M		39.726622 ° -121.781545 °	39.726622 ° -121.781545 °	1 Y

Levee Mile Report Line	1
Start Levee Mile	0.70
End Levee Mile	0.70
Location	Crown
Category	Earthen Levee
Item	Repair Gates
View of the gate needing to be repaired. The hinge on this gate has broken.	
rduffey_f_20111128_513.jpg
